POSTIRRADIATION EXAMINATION OF THE
PM-3A TYPE 1 SERIAL 2 CORE
PART I. POSTIRRADIATION EXAMINATION
OF FUEL TUBES

February 28, 1967

John B. Brown, Victor W. Storhok, and John E. Gates

BATTELLE MEMORIAL INSTITUTE
Columbus Laboratories
505 King Avenue
Columbus, Ohio 43201

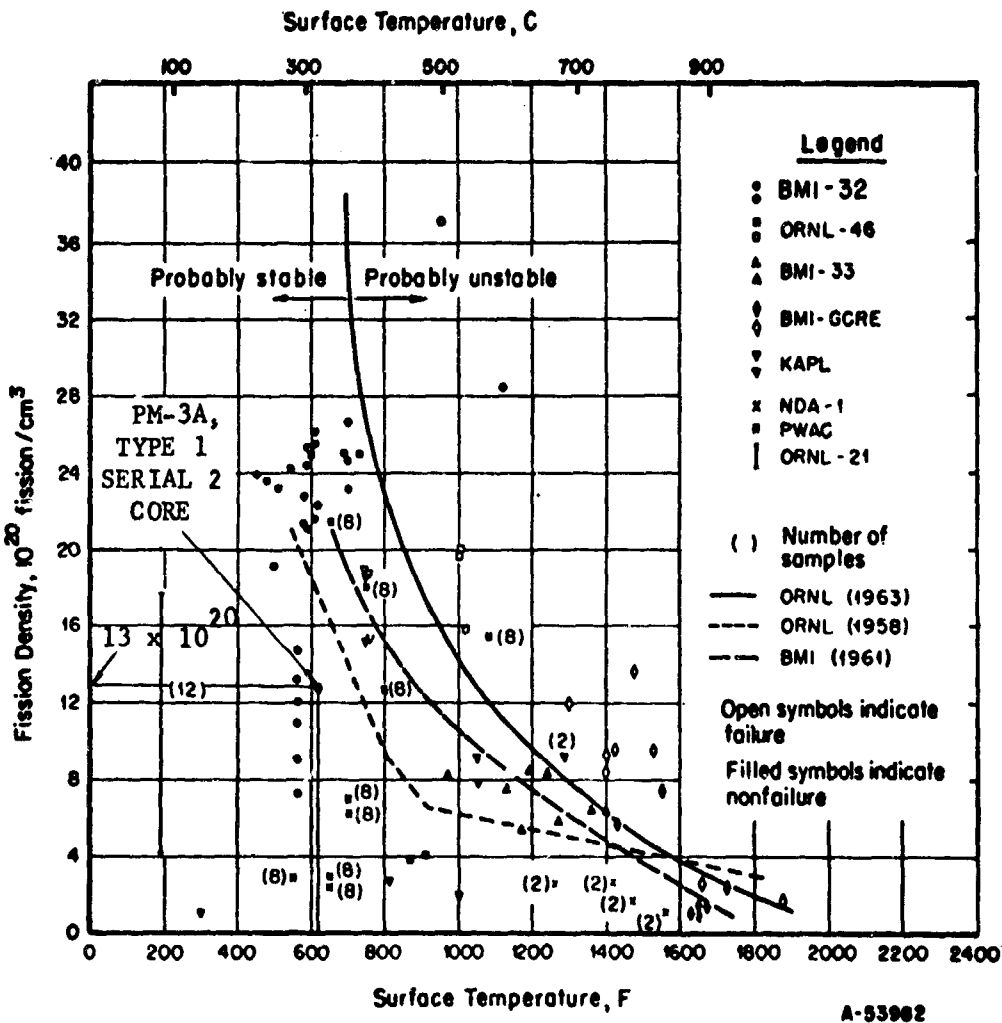
FIGURE 26. IRRADIATION PERFORMANCE OF STAINLESS STEEL-UO₂ DISPERSIONS⁽¹⁴⁾

The cause of the failure is not clear. Based on the results of irradiation tests of plate specimens, other investigators⁽¹⁴⁾ have predicted failure of UO_2 -stainless steel dispersions as a function of burnup and temperature as shown in Figure 26. Based on the data shown in Figure 26, and a burnup of 13×10^{20} fissions/cm³ and a surface temperature of 620 F, the PM-3A, Type 1 Serial 2 Core clearly operated in the probably-stable-region of the plot for this type of fuel. Perturbations to heat flow introduced by the oxide scale on the PM-3A fuel tube surfaces may have raised fuel operating temperature slightly and shifted the operating point toward the stable-unstable boundary. However, it seems unlikely that the presence of the scale could

have raised temperature sufficiently to bring the operating conditions into the non-stable region of the data shown in Figure 26.
